# **Phase I Test Results**

## **Joint Test Protocol for Cadmium Alternatives for High Strength Steel**

Erin Beck

January 2006

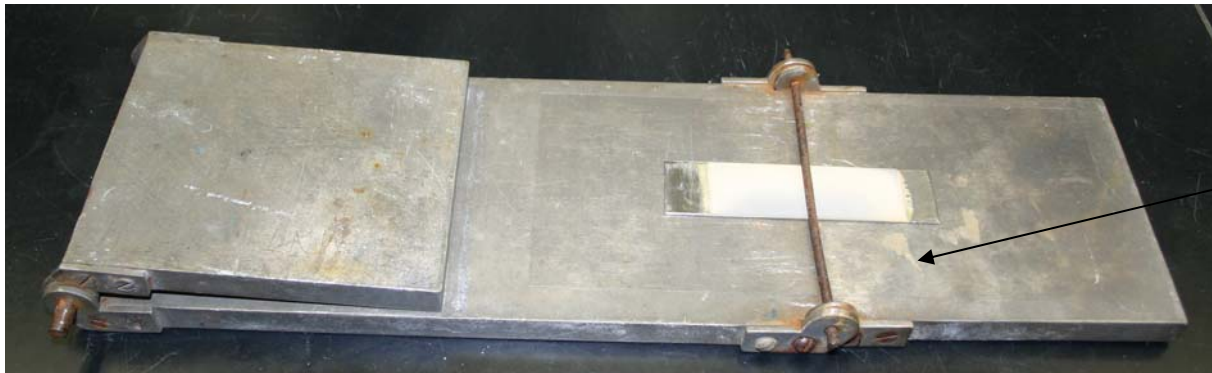
- **Acceptance Criteria:** No separation (flaking, peeling, or blistering) of the coating from the basis metal. Cracking is acceptable.
- **Test Setup:** Bend specimen back and forth through 180° until coating and/or substrate ruptures.
- **Performance:** IVD Aluminum, Brush LHE Cadmium and Sermetel 249/273 had adhesion problems.

Protective  
transparency  
sheet under  
panel.

Coating	Pass/Fail	Comment
LHE Cadmium	Pass	
IVD Aluminum	Fail	Significant flaking/peeling
Alumiplate	Pass	Very minor peeling at broken edge
Zn-Ni (Boeing, acidic)	Pass	
Sputtered Aluminum	Pass	
Brush LHE Cadmium	Fail	Significant flaking/peeling
Brush Sn-Zn	Pass	
Sermetel 249/273	Fail	Significant flaking/peeling/blistering
Brush Zn-Ni	Pass	
Zn-Ni (Dipsol LHE)	Pass	
Sn-Zn	Pass
